PRELIMINARY GEOTECHNICAL ENGINEERING REPORT
Oregon Zoo Train Track Restoration
PORTLAND, OREGON

Subject: DRAFT PRELIMINARY GEOTECHNICAL ENGINEERING REPORT,
OREGON ZOO TRAIN TRACK RESTORATION, PORTLAND, OREGON

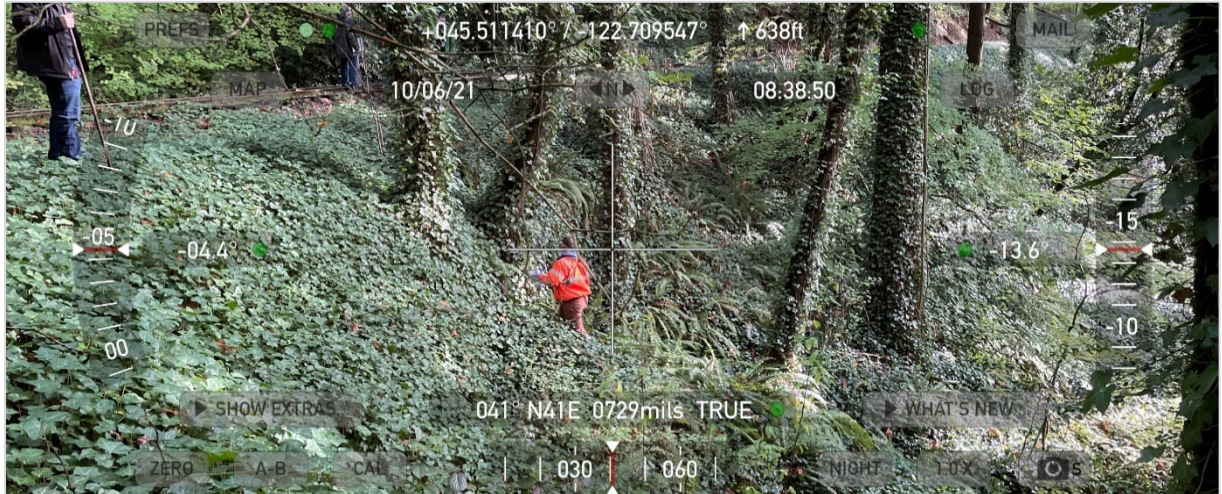
Previous notes indicate that the wall face is covered with fern and vine growth. During the current site reconnaissance, fern and vine growth is still observed covering the face of the wall. However, large trees were also observed growing behind crib wall 1 as seen in Exhibit 5-1.

Exhibit 5-1: Trees and underbrush growing over existing crib wall 1

Previous notes also indicated rotting of the wall timbers, which was equated to age and poor or inadequate drainage conditions behind and within the wall. Slumping of the track subgrade and outward rotation of the wall face were not observed previously. However, the previous site reconnaissance noted some downward expression of the wall at butting locations.

We did not observe slumping of track subgrade or outward rotation of the wall. We recommend cutting the trees growing in the wall to prevent them from causing further damage. In our opinion, the risk of sudden, catastrophic failure of the wall is low unless the culvert is blocked during a period of heavy rain. We recommend the wall be monitored to determine if additional wall deformation is occurring and to confirm Culvert 3 remains clear and able to drain. We also recommend that wall replacement be included as part of a long-term maintenance plan.

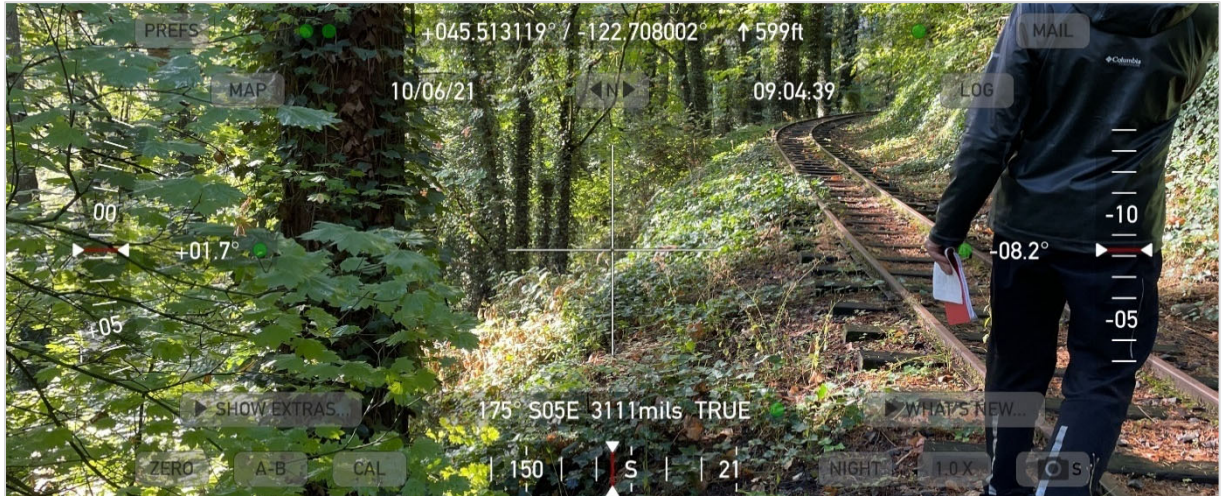
Crib wall 2 supports the "Texas" gulch area of the existing alignment. Previous notes indicate that bulging of the wall near its northern extent was observed. Current observations did not note bulging in the wall, however heavy vegetation impeded visual

observation. No disruption to the track structure or alignment was observed. A photo of the wall and vegetation is provided in Exhibit 5-2.

Exhibit 5-2: Heavy vegetation covering crib wall 2

Zoo staff indicated that the track within this portion of the alignment has required surfacing to accommodate settlement in the past. Continued track settlement is likely related to heavy rainfall and displacements of crib wall 2. We recommend continued monitoring of the wall.

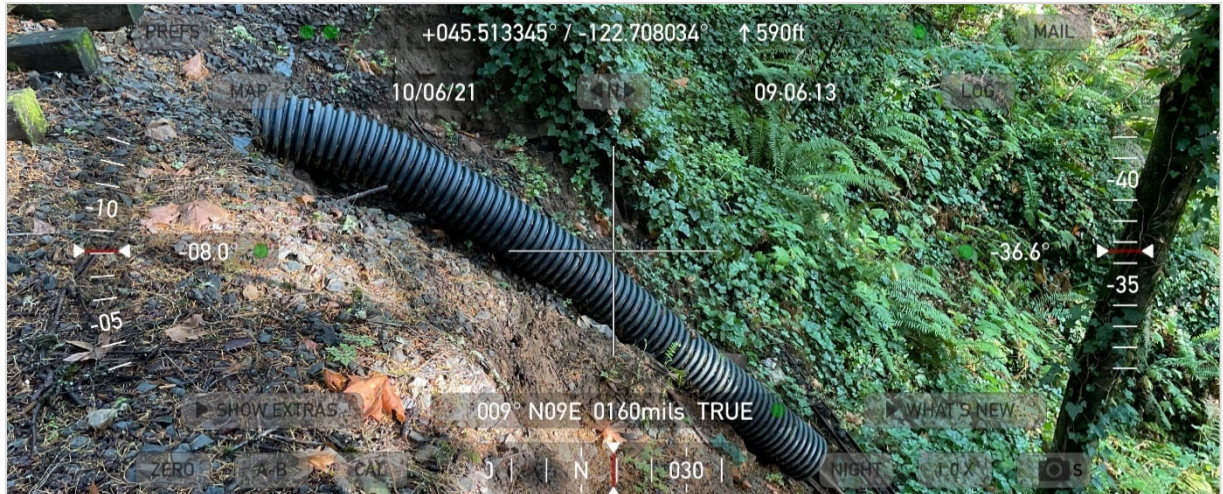
As described in previous reports, crib wall 3 overlies culvert 6 which was to be replaced to correct drainage upslope of the track. During the replacement of culvert 6, a failure of crib wall 3 occurred due to rotting of the timbers and saturated ground conditions caused by uncontrolled drainage allowing water to collect behind wall. After the failure a replacement culvert was installed consisting of a 10-inch diameter corrugated HDPE pipe as shown in Exhibit 5-3. Current observations indicate that the inlet of culvert (Culvert No. 6) may be partially clogged and needs to be cleaned out. The current wall also needs to be replaced. A new soldier pile wall is likely the most feasible mitigation option. As an alternative, a short bridge could be installed to span the erosion area.

Exhibit 5-3: Replacement pipe installed at culvert 6

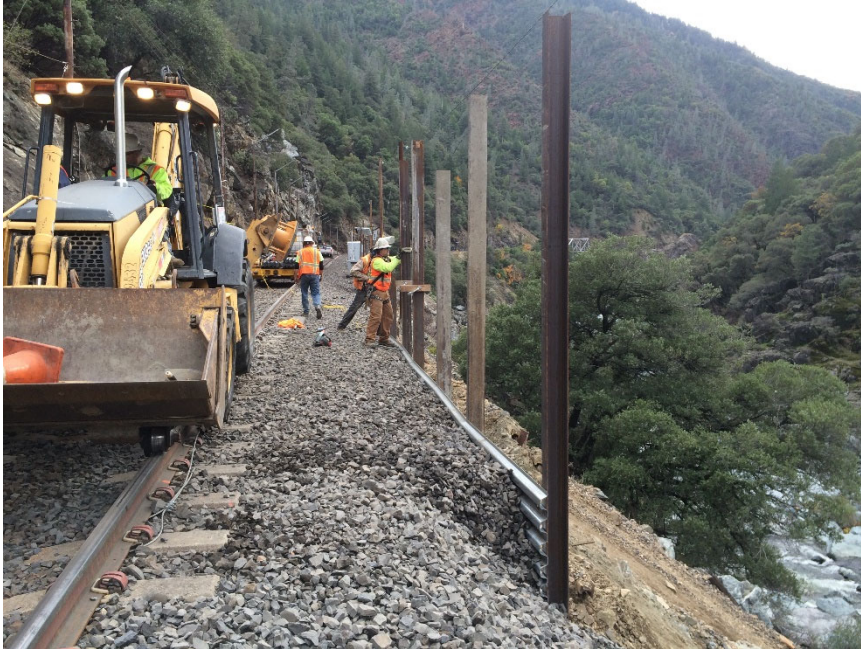
Exhibit 6-1: Installation of a soldier pile wall used for railroad embankment support on steep slope on a rail alignment in California

The proposed soldier pile and lagging retaining walls should be designed to resist lateral earth pressures acting from the retained soil and train or vehicle surcharge loading adjacent to the wall. The walls will mobilize passive resistance against the embedded length of pile sections. The anticipated failure plane for future slope instability is likely to occur at the interface of the soil and the underlying rock. For conceptual design purposes, we recommend that the soldier piles be embedded into the basalt bedrock. Previous explorations B-6 and B-7 were performed near the north and south ends of Crib Wall 3, respectively. Decomposed basalt was encountered at a depth of 10 feet in B-7. Boring B-6 was terminated at a depth of 11.5 feet in gravel/cobble material.

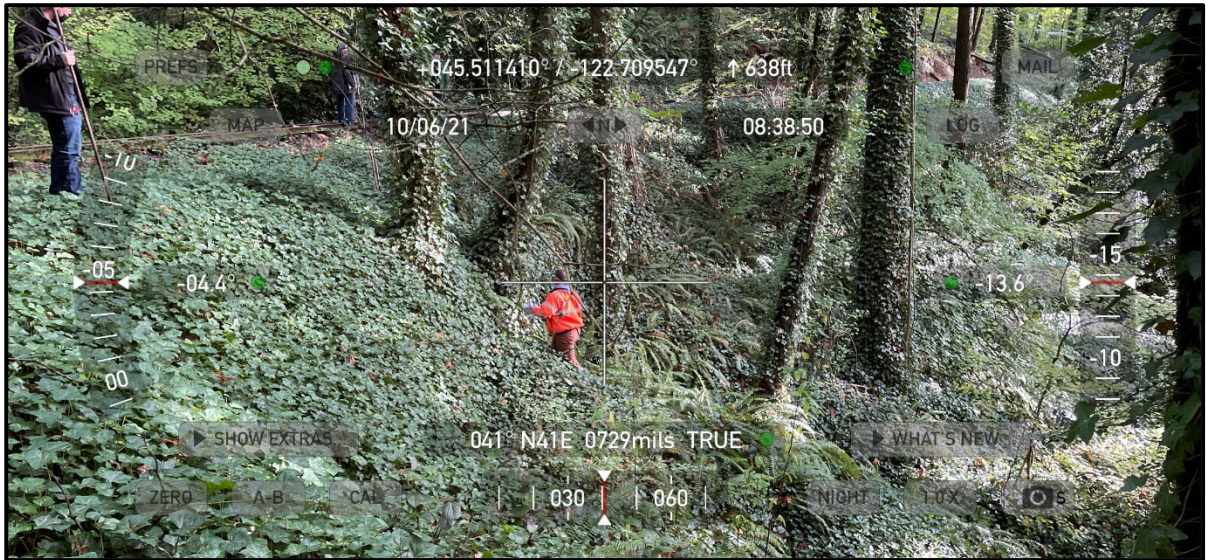
Photo TH000003: Crib Wall 1 looking northeast

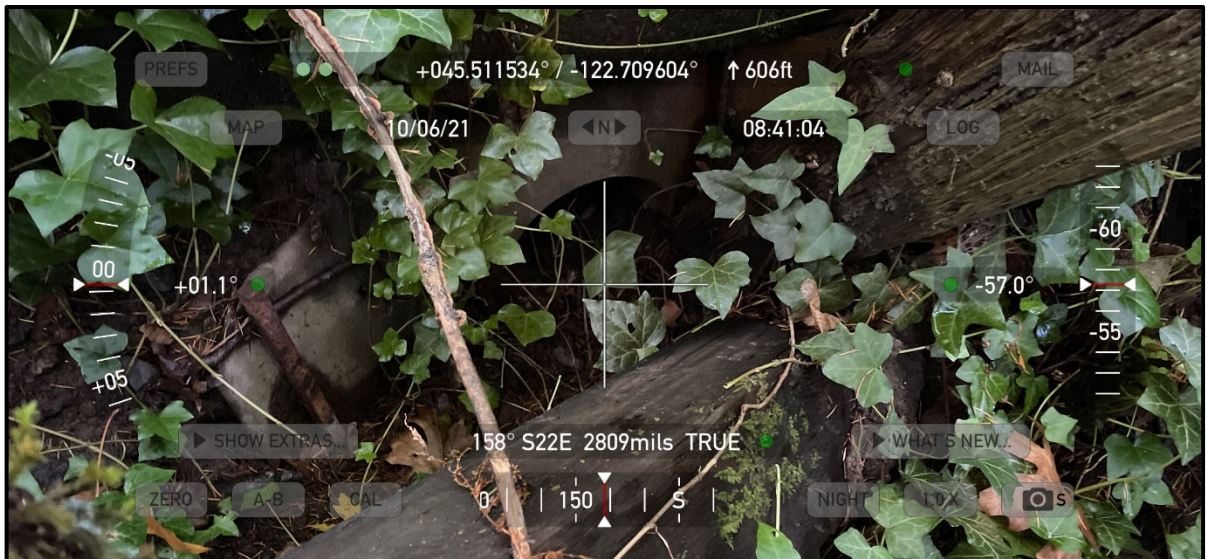
that collects drainage upslope of the tracks and then directs it below the lowest point of crib wall 1. Previous notes indicate that culvert 3 has a rusted bottom allowing water to saturate the timber members which promotes rot.

Photo TH000004: Culvert 3

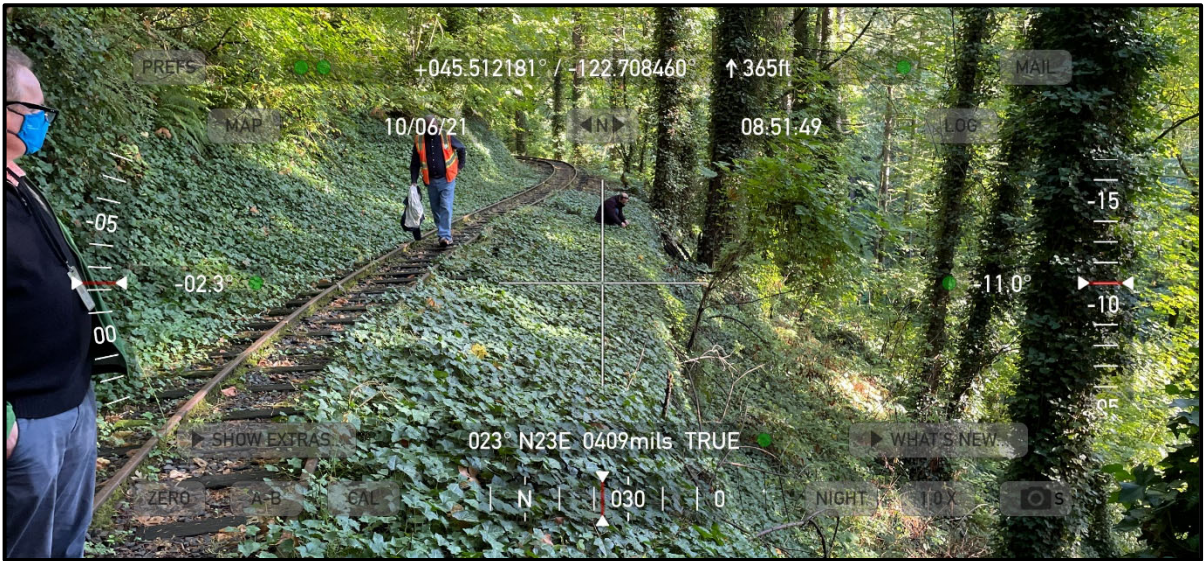
Photo TH000006: Potential slump west of tracks looking north

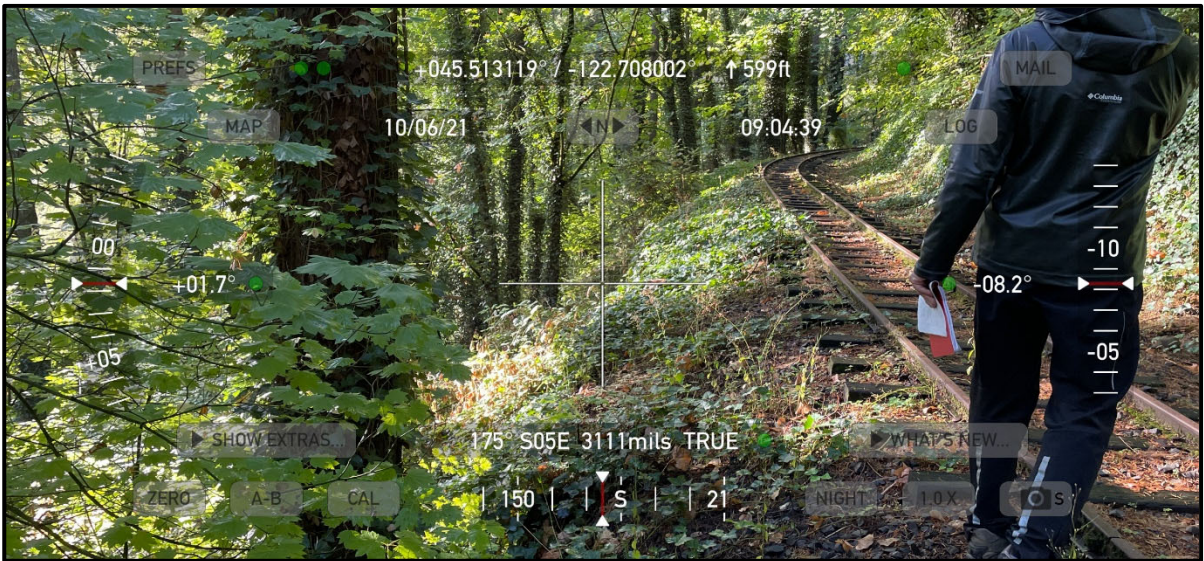
Photo TH000007: Crib Wall 2 / "Texas" Gulch looking south

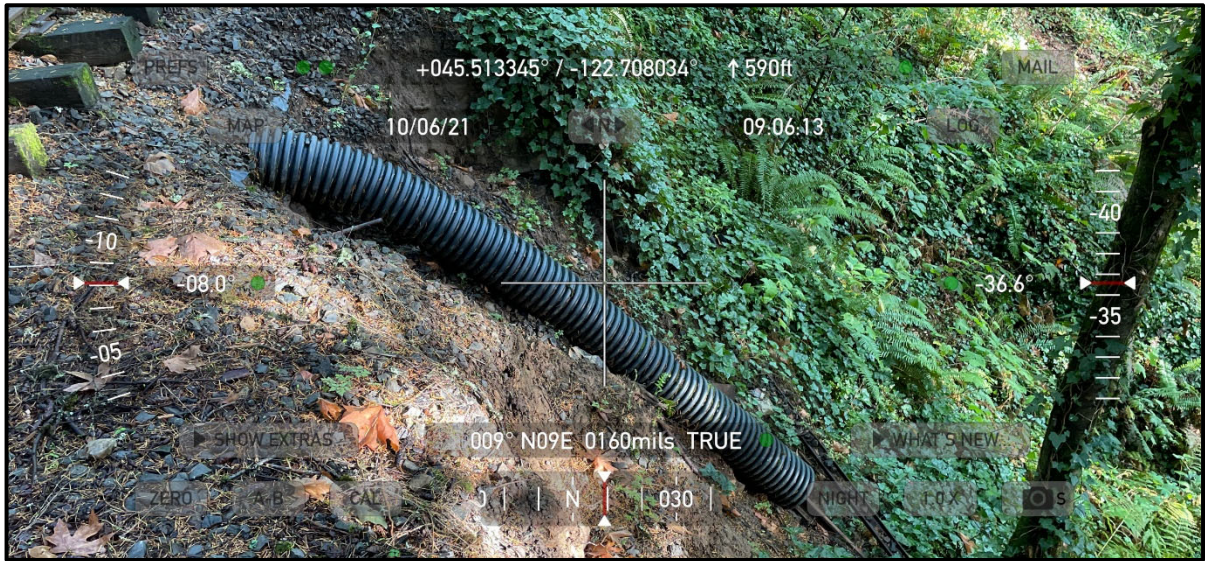
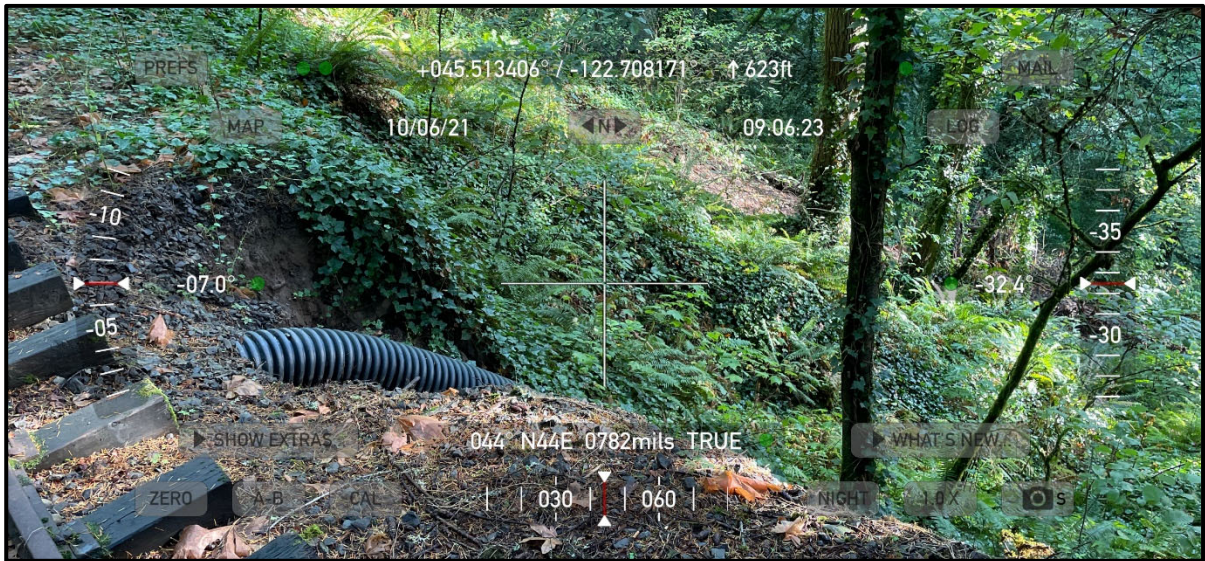
Photo TH000008: Culvert 6 looking north

Photo TH000009: Culvert 6 looking north

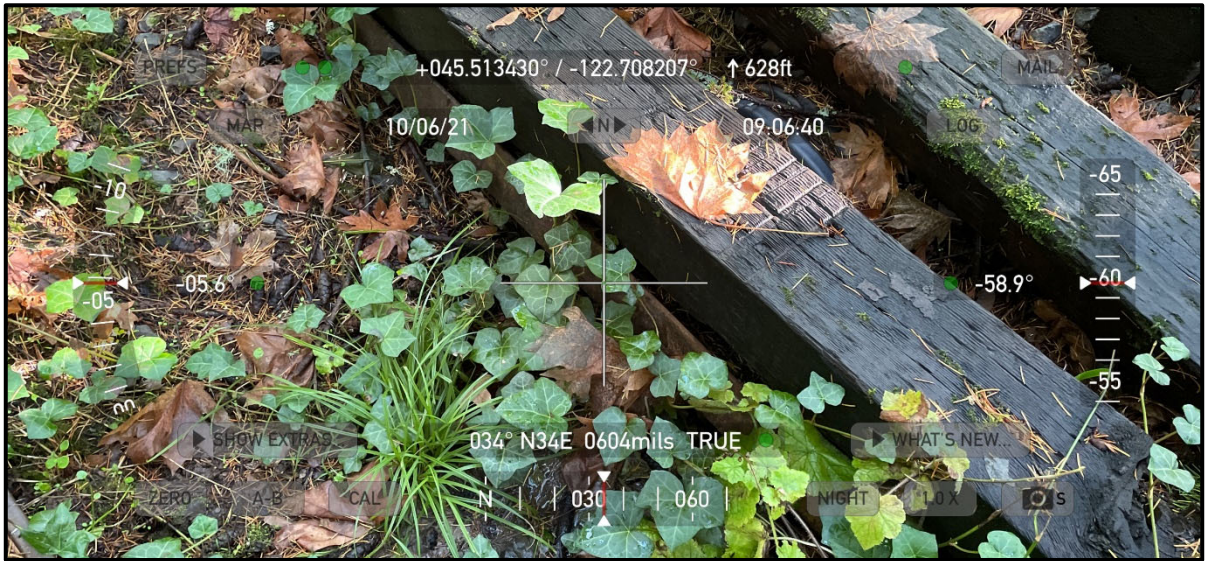
Photo TH00010: Culvert 6 underlying wood timbers

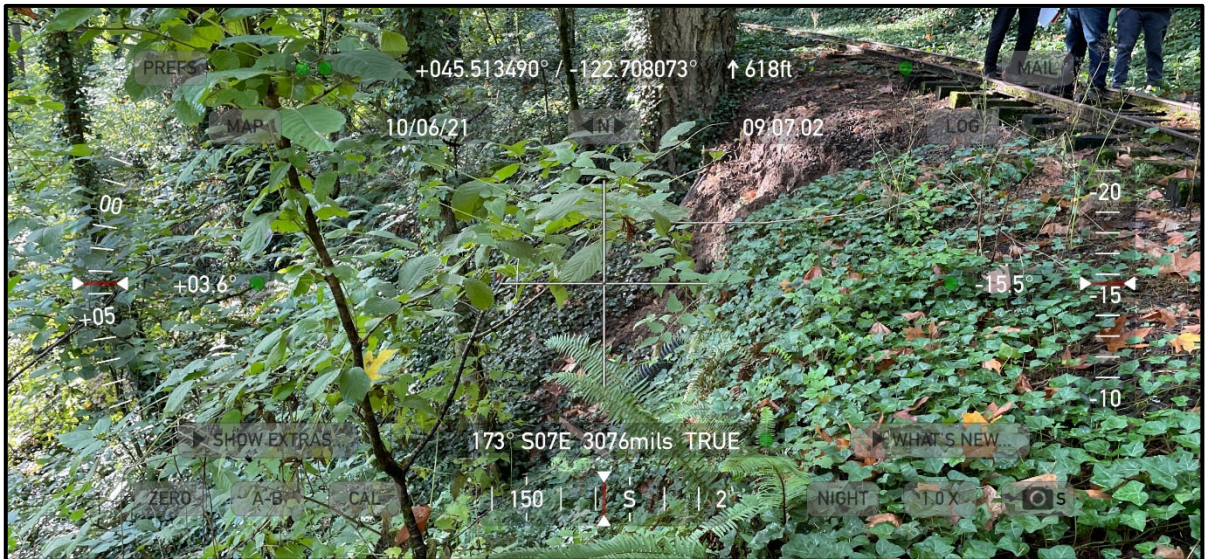
- Crib Wall Number 3 (STA 16+65 to 17+07) has failed as a result of uncontrolled drainage during a storm and is not retaining the track shoulder. A new retaining wall is required at this location before operations can resume. For planning purposes, we assume a 10-foot tall by 40-foot-long soldier pile wall will be required. We recommend final design for the structure be performed. As an alternative a short bridge could be evaluated during design. Estimated design and construction cost was \$150,000 in 2021 dollars. If the construction cost escalations experienced over the last 5 years (2019-2023) continue, the cost of construction to complete the design concept in 2026 may be \$225,000.

Photo TH00011: Crib Wall 3 looking south

To support final design of Crib Wall 3, we recommend supplementing the existing explorations by performing a minimum of one geotechnical boring to a depth 25 feet (and a minimum of 5 feet into bedrock), to characterize the rock for design and bidding purposes. The explorations will be used to support a detailed internal and global stability analysis of the wall for final design.

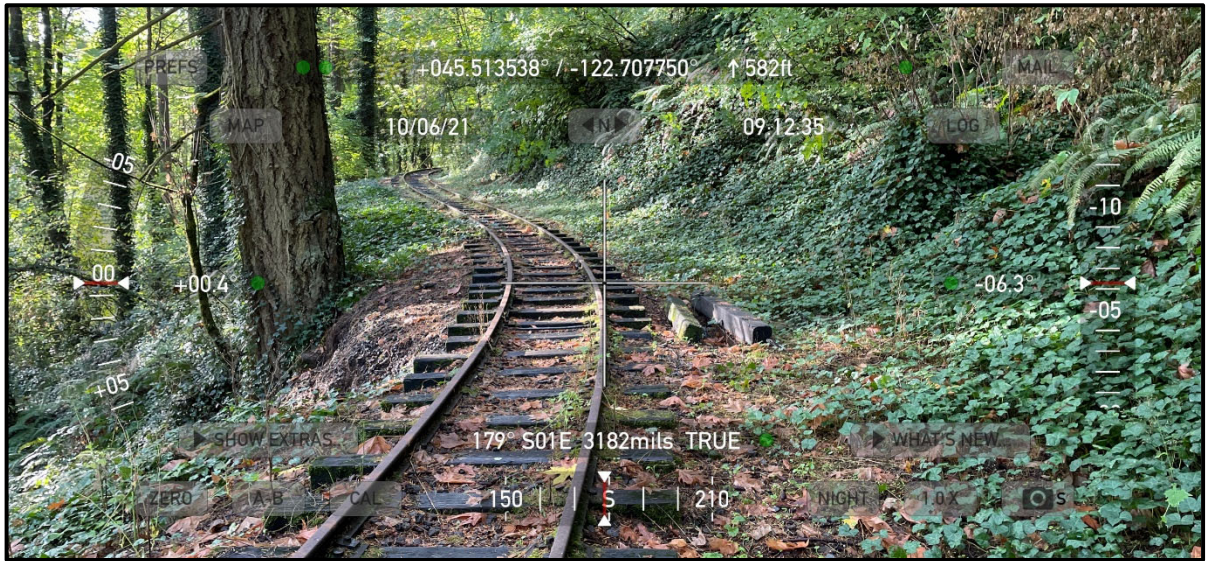
Photo TH00012: Alignment near Crib Wall 3 and Culvert 6 looking south

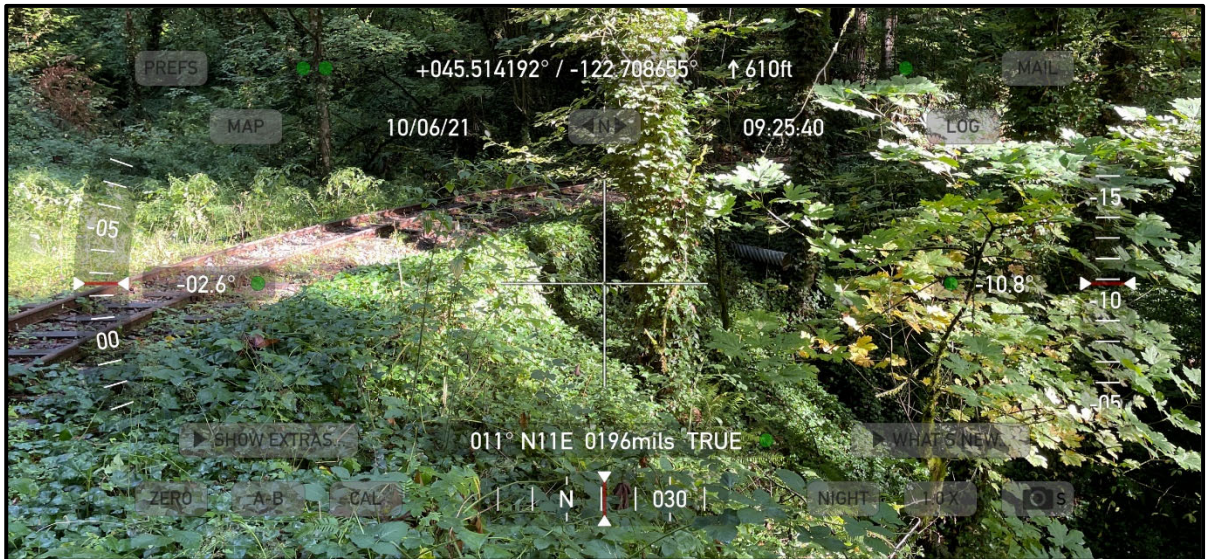
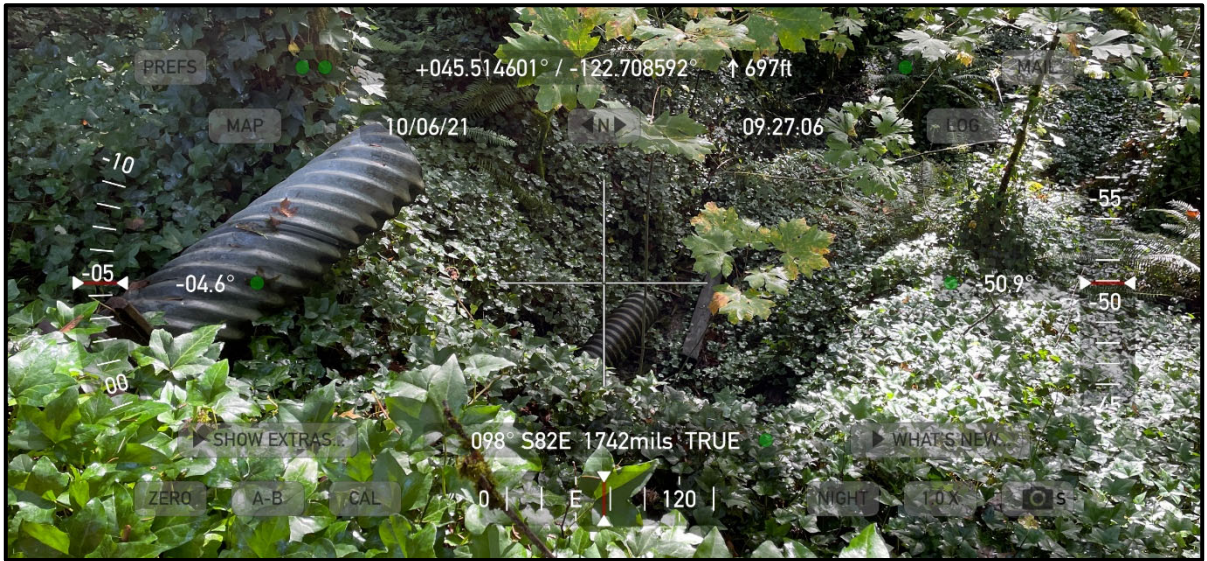
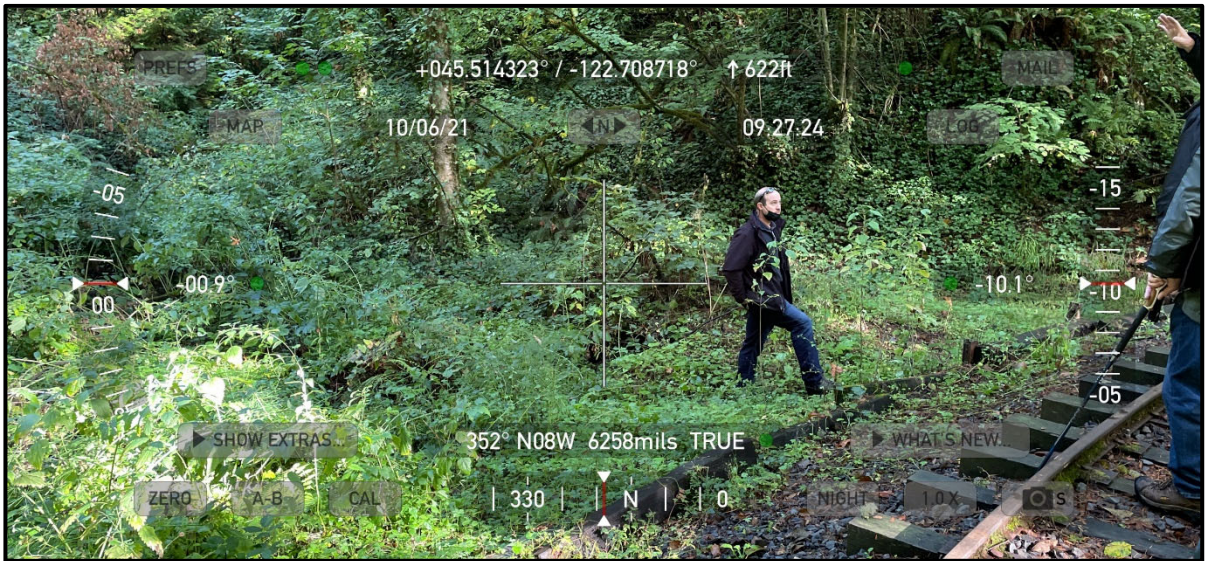
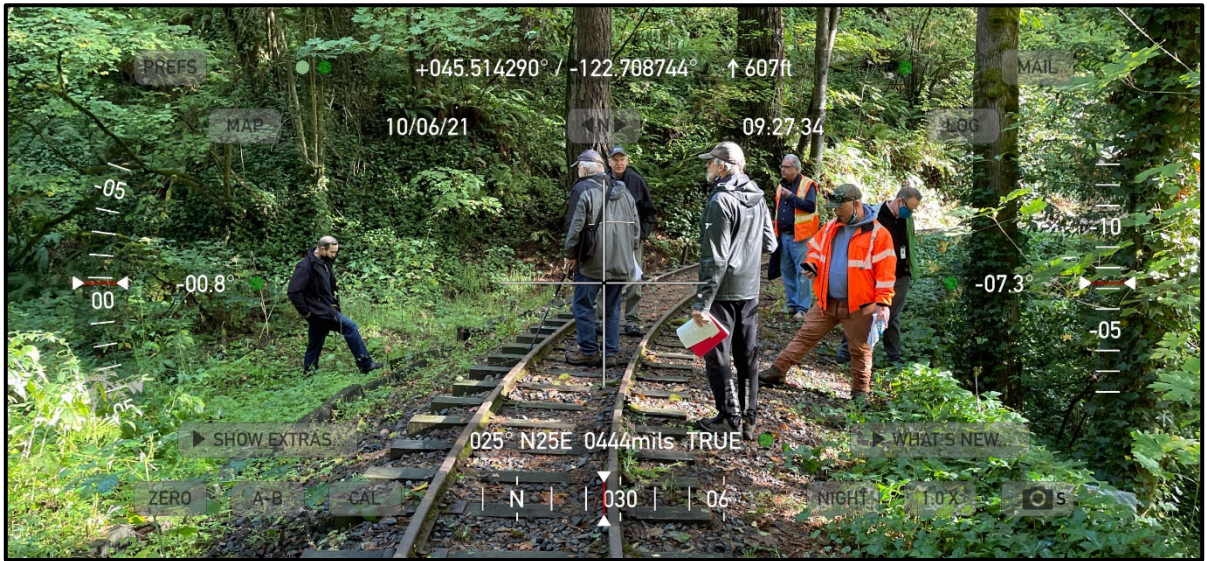
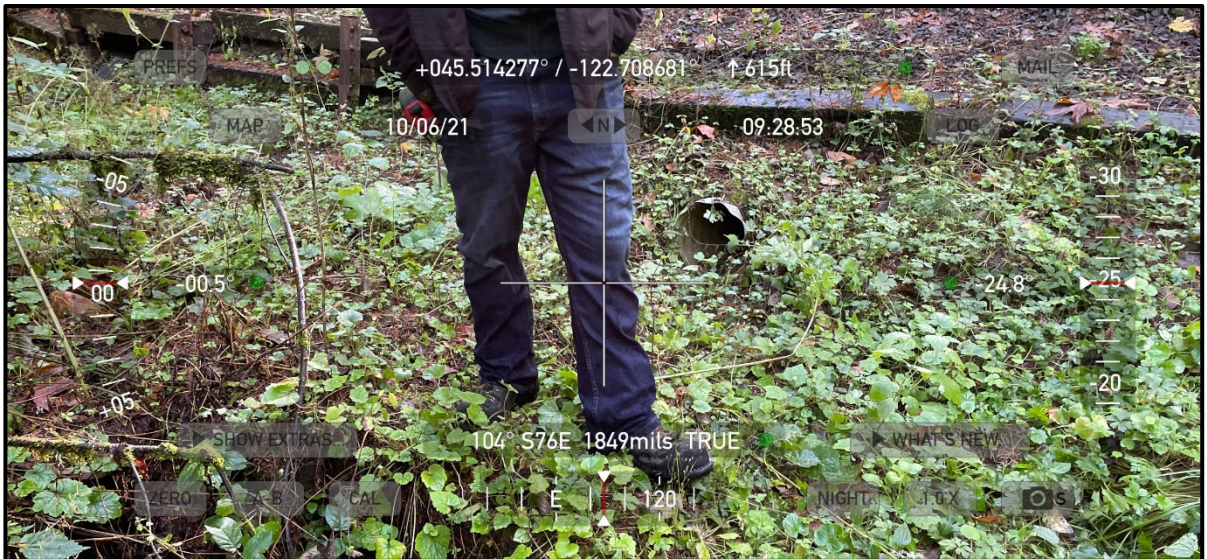
Culvert (8a) consists of a 12-inch CMP originally intended to be the primary culvert. The inlet of culvert 8a has been covered by erosion of upslope material and currently appears to be blocked. A secondary culvert (8b) is located above culvert 8A and is in relatively good condition. We recommend grouting Culvert 8a and grading the inlet area to direct water into culvert 8b. This work can be performed as part of a maintenance plan for the alignment.

Photo TH00015: Culvert 8 looking north

Photo TH000016: Culvert 8 looking southeast

Photo TH000017: Area near Culvert 8 looking northeast

Photo TH000018: Alignment at Culvert 8 looking east

Photo TH000019: Culvert 8 looking southeast

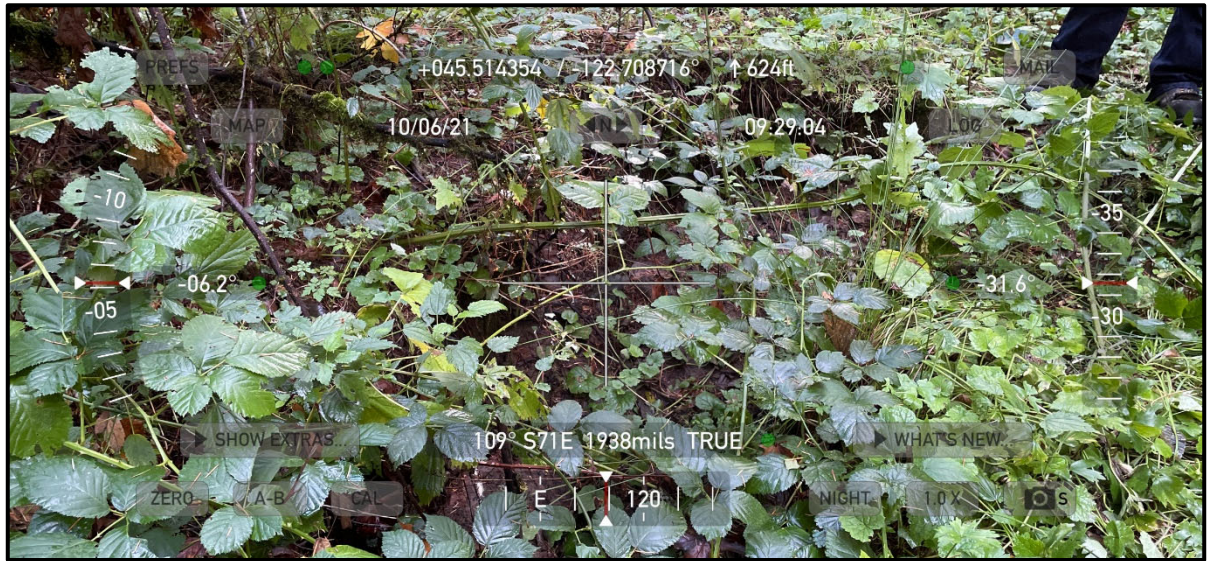
Photo TH00020: Inlet for Culvert 8

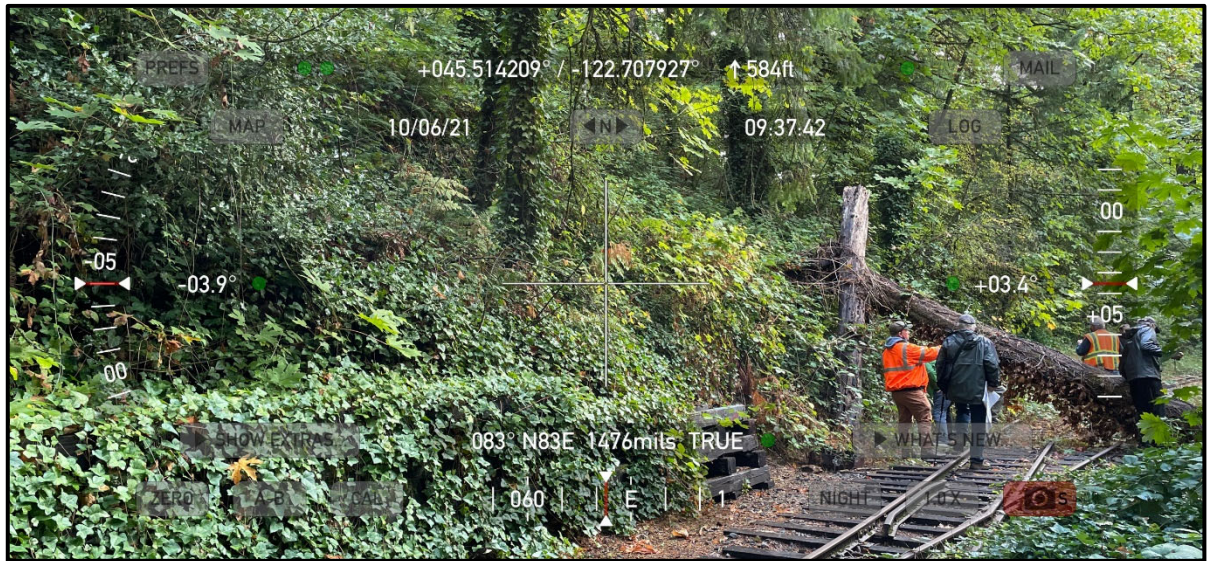
Photo TH00021: Area near 1980's landslide and Culvert 9 looking southeast

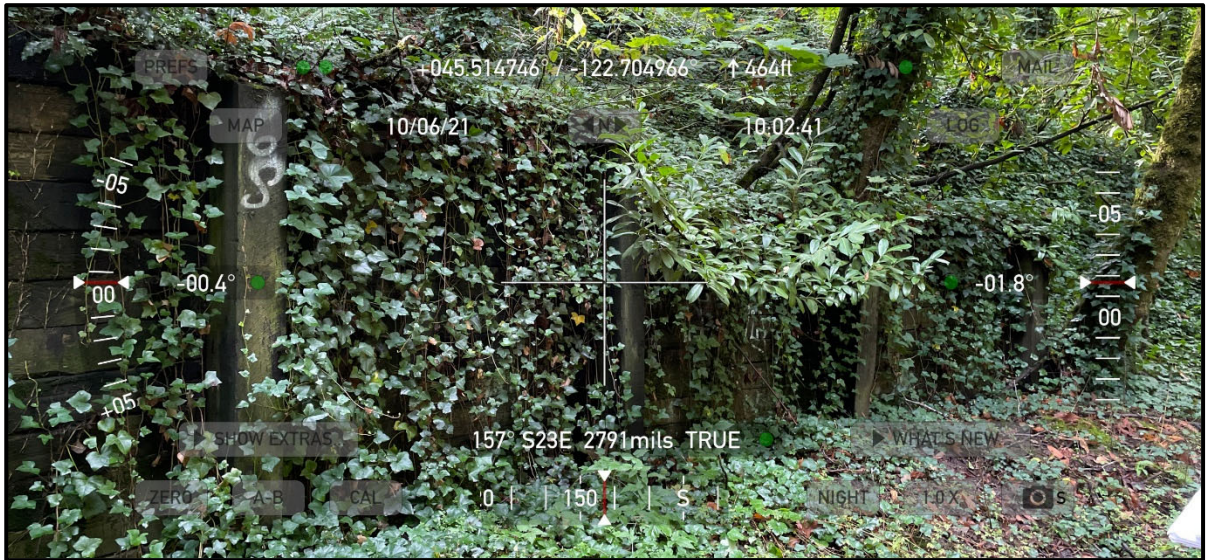
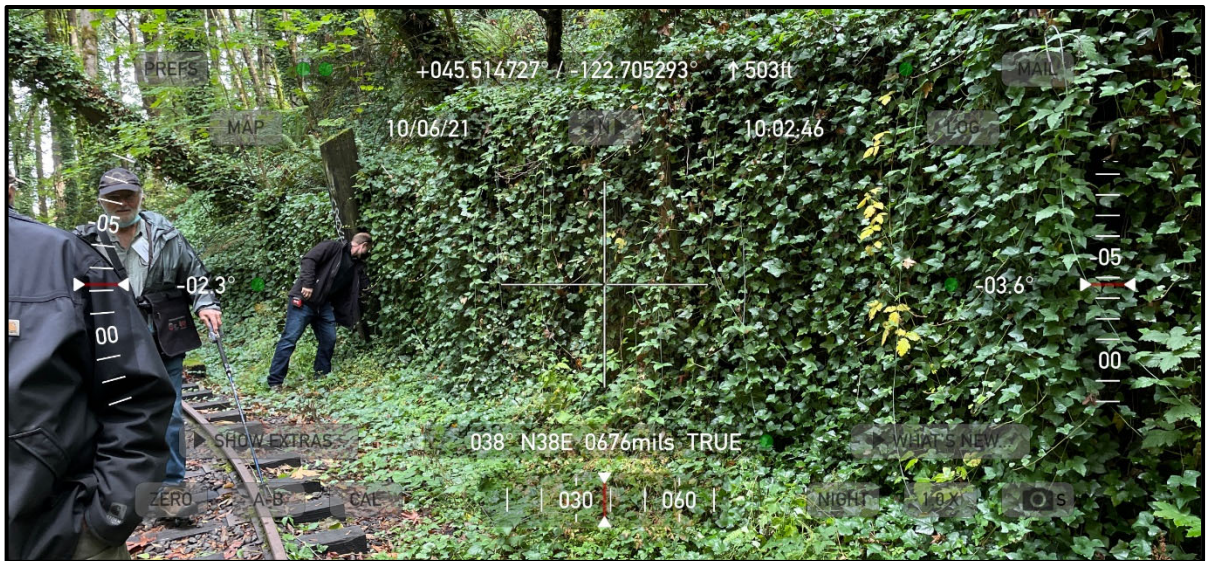
Photo TH00023: Timber Wall east of tracks near Culvert 14 looking southwest

Photo TH00024: Timber Wall east of tracks near Culvert 14 looking northeast

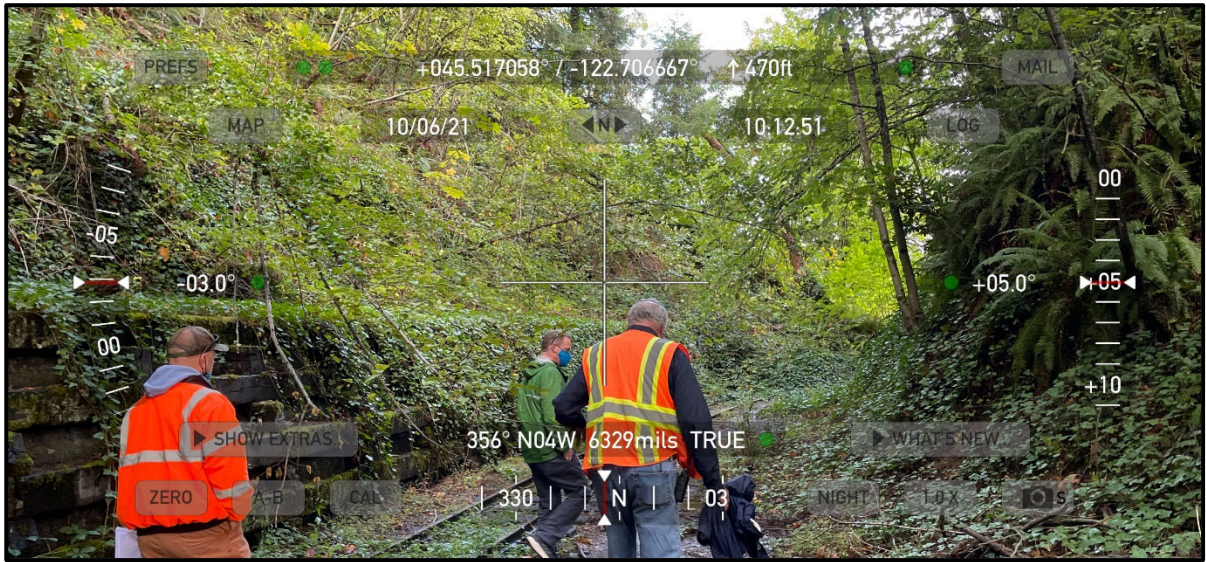
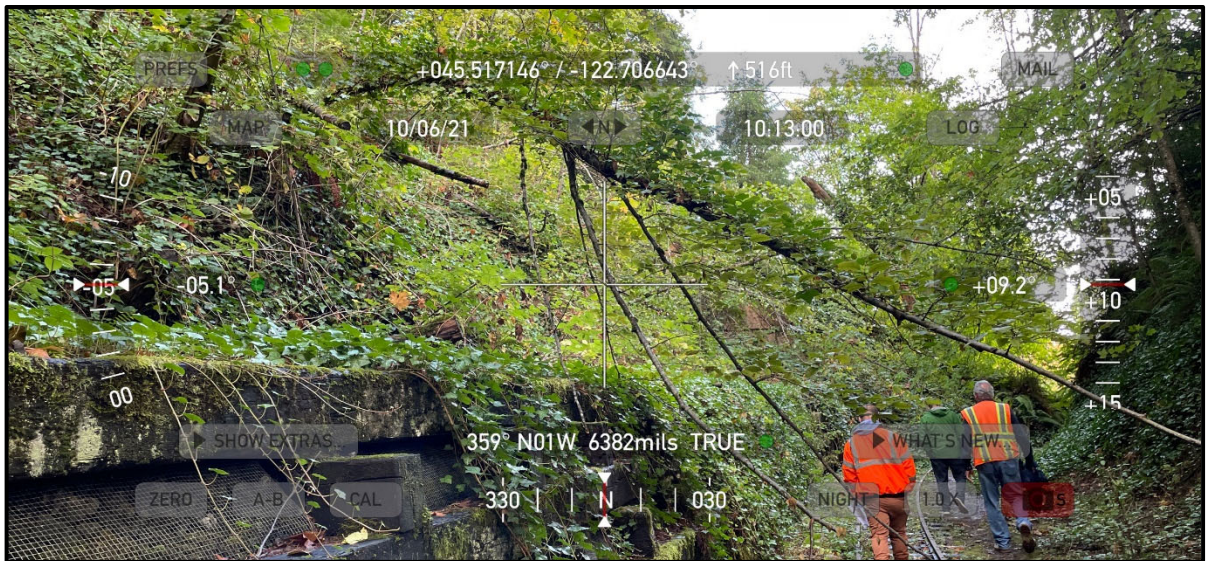
- A slide from an adjacent bluff at Station 56+00 has covered the track with slide debris and trees and needs to be cleared. We estimate the volume of the slide debris at around 300 cubic yards. After removing the debris, we recommend performing an assessment of that portion of the track and adjacent retaining wall. For slide debris removal and cleanup, we recommended a budget of \$40,000 in 2021 dollars. If the construction cost escalations experienced over the last 5 years (2019-2023) continue, the cost of construction to complete the debris removal in 2026 may be \$60,000.

A landslide occurred between the approximate stations of 54+80 to 57+10 in 1997 after a period of extended rainfall. Information from historic reports indicates the slide was buttressed and repaired with a crib wall. During our October site reconnaissance, the railroad tracks were covered with an estimated 20 foot by 10 foot by 40-foot-wide volume of slide debris originating from above the crib wall. It is unclear if the recent slide caused damage to the wall or simply overtopped the wall. The landslide debris should be cleared from the tracks and damage to the wall evaluated. This area will continue to require clean up following slides caused by heavy rainfall, however, as long as the train is only operated during summer months and when the weather is dry, the risk of sliding during these times is very low. We recommend on-going monitoring of the slide area be performed.

Photo TH000025: Area near 1997 landslide looking north (appr. STA 56+00 to 57+00)

Photo TH000026: Area near 1997 landslide looking north (appr. STA 56+00 to 57+00)
